**Justin & Mallory Fiske (Owners)**  
**1517 Iroquois St**  
**Indian Village**  
**HDC Project Review Request**  
**Front Brick Walkway Restoration & Repair Project**

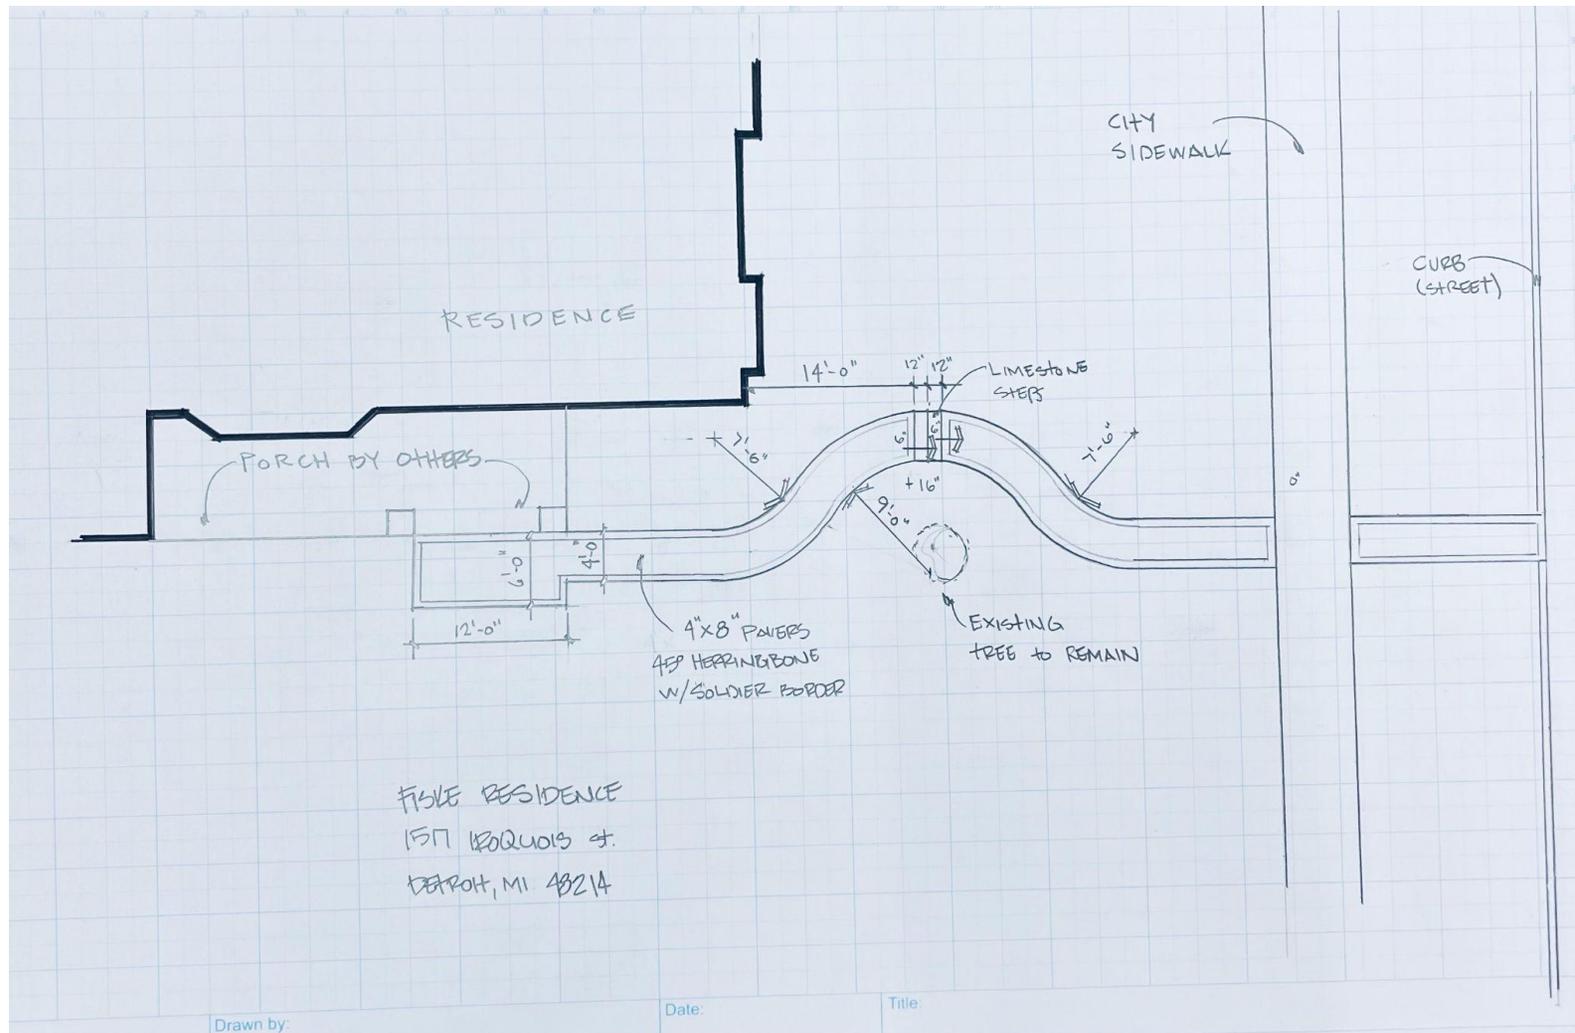
### 1) The Floor Plan

Description: The current walkway is a direct line toward the side entry porch side. This plan shows the new walkway safely re-routed 9.0' from tree radius to avoid major tree roots and roots disrupting uneven soil. The two 16" grade steps are at the path 90 degree 'arch' not to exceed the perpendicular main house line to retain historic preservation of a main side entrance.

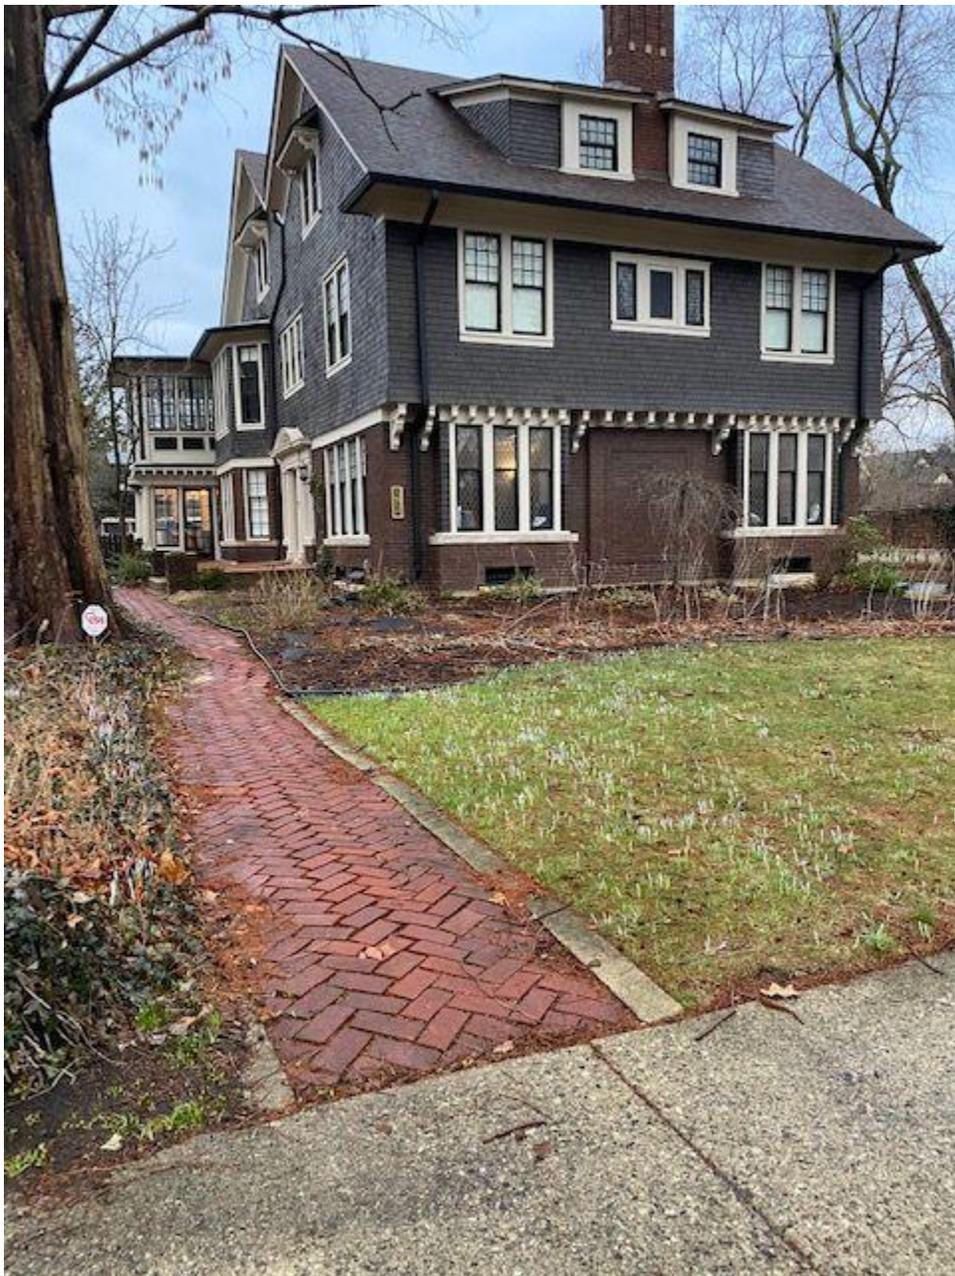
View 1 from sidewalk showing original placement of brick pathway directly into 100' tree trunk and roots.

The current brick walkway is located on the berm (between Iroquois St and city sidewalk) and the main property front yard from city sidewalk to side main entrance porch. Over the decades, the brick pathway has fell into disrepair with the soil and tree roots underneath the pathway making the bricks misleveled and cracked. In addition, there is a 60 year old large 100 foot tree with large roots that has significantly disrepaired the middle part of pathway and upped the soil. This has caused the brick walkway to crack and lift from its original placement and where it's now a safety hazard without steps slightly rerouted and releveled. Many bricks along the walkway are salvageable to reuse/restore but some are cracked or broken needing identical replacement.

The end goal is to restore the beautiful brick pathway up to both historic charm (i.e. retaining the integrity of the side entry historic home) while meeting basic safety protocols. The plan is to keep and restore the majority of bricks and replace any broken/cracked/unsafe bricks with 'of the like' historic bricks. The historic 100 foot tree roots on the property line of 1517 Iroquois (our home) and 1507 (our neighbors) has lifted the soil and brick pathway up a 16" grade where two steps are now needed. The walkway was originally a straight path direct to the front porch before the 100 foot tree was planted ~60 years ago. The pathway literally runs directly into the tree trunk and large roots. Now with the tree in place, the safest path is for it to curve around in a half circle 9 feet from the trunk and then reconnect back to the original straight line to the side of the porch steps.

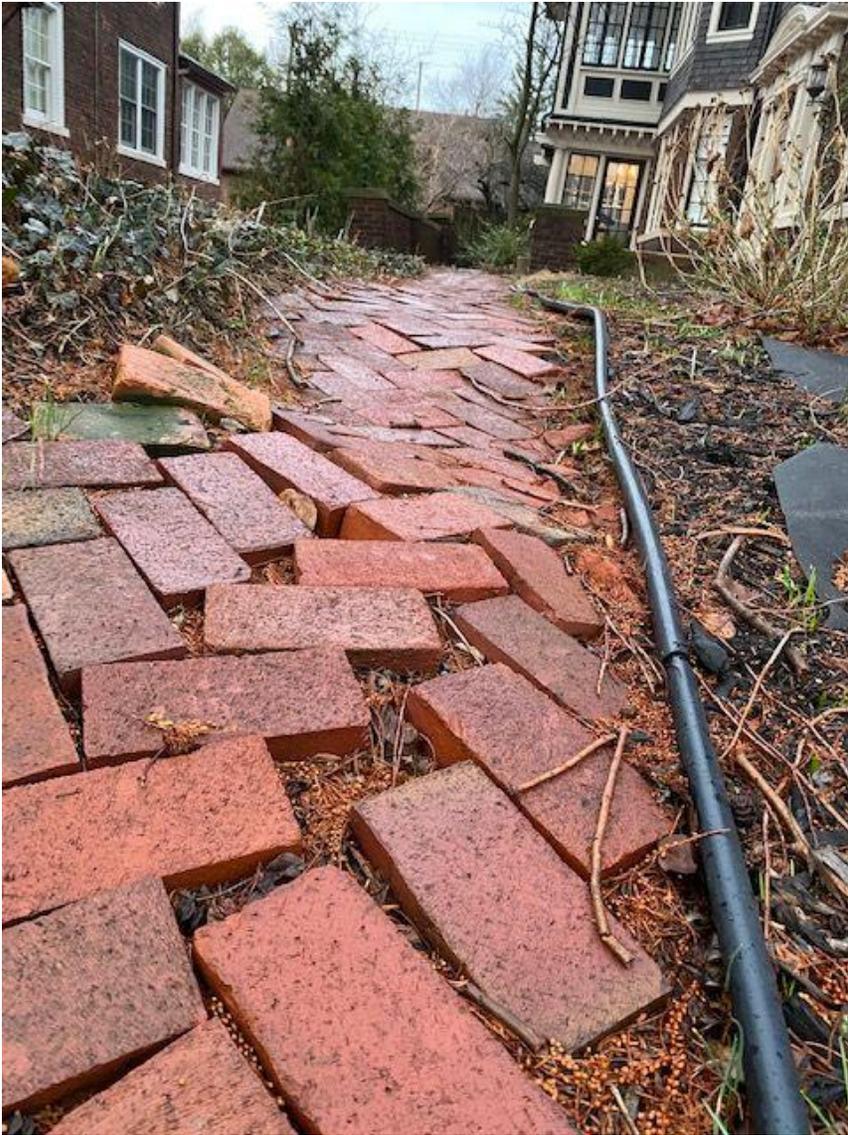
View 2: Showing bricks raised and in disrepair from 100 ft tree roots

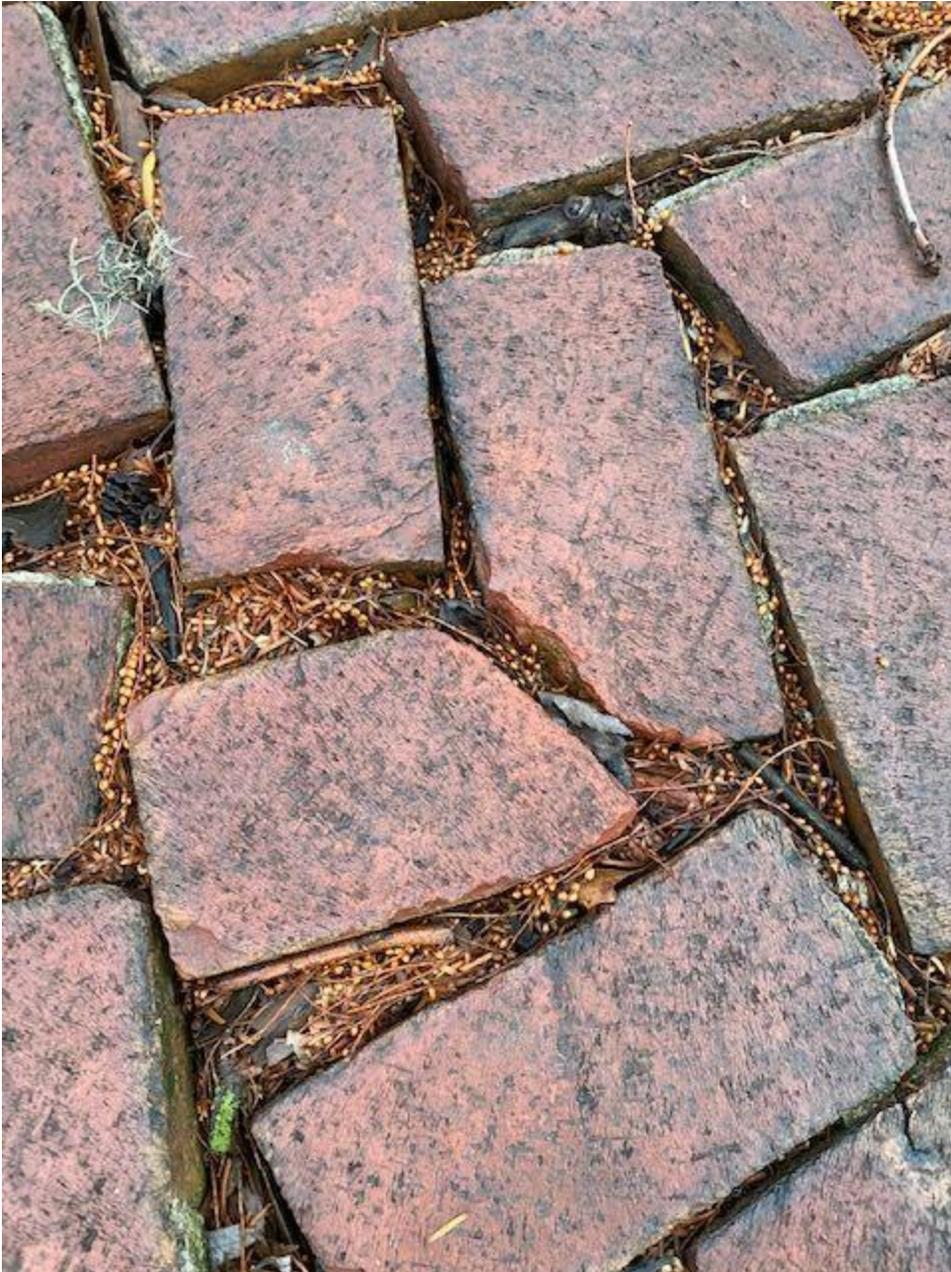
View 3: Close up view of cracked and unsafe uneven bricks.

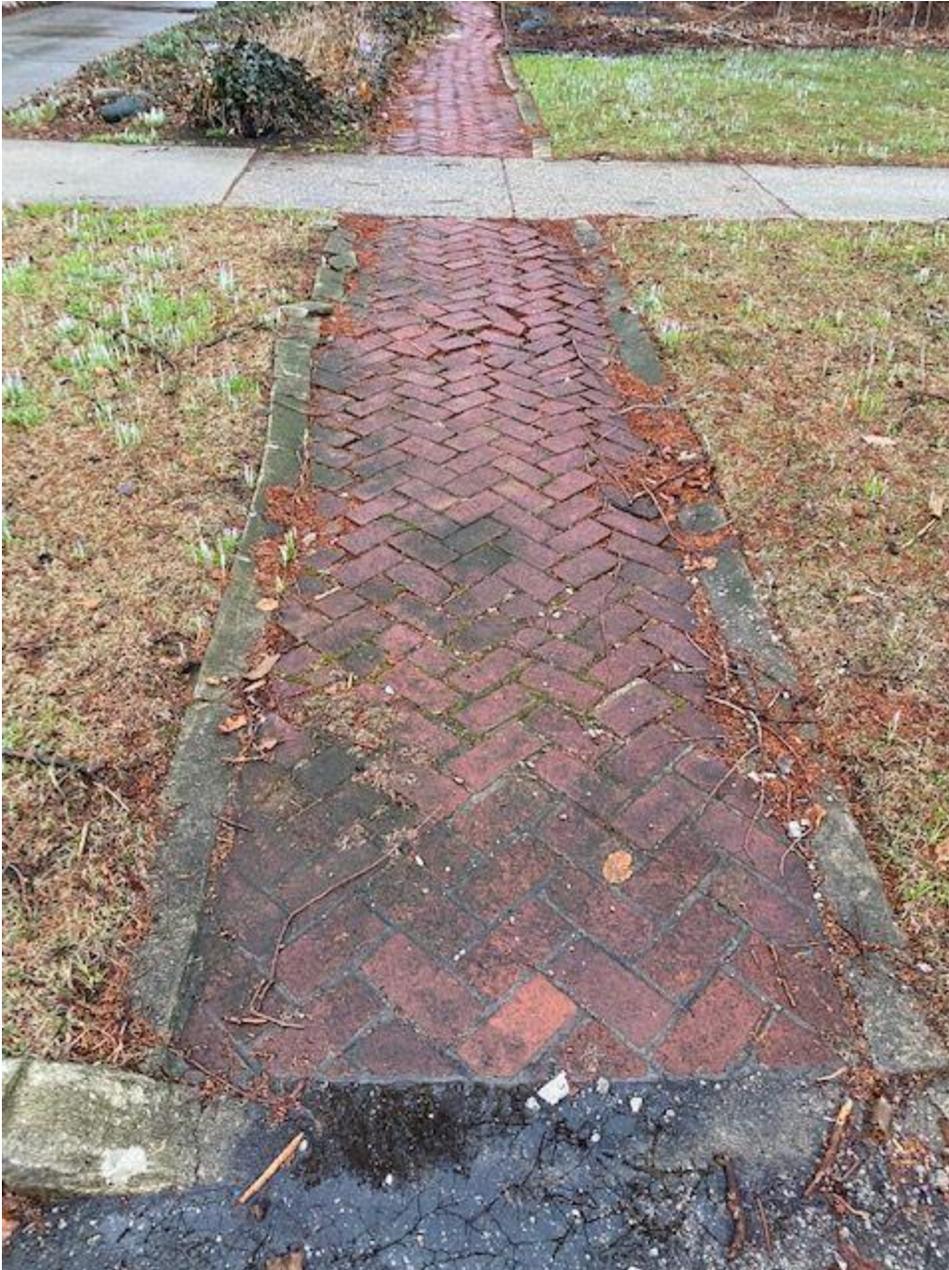
View 4: View from Iroquois Street berm pathway. This layout will remain the same, just relaying the bricks with support grid and sand underneath to restore / repair / level the pathway and to make it safer since the majority of the bricks are angled up or broken.

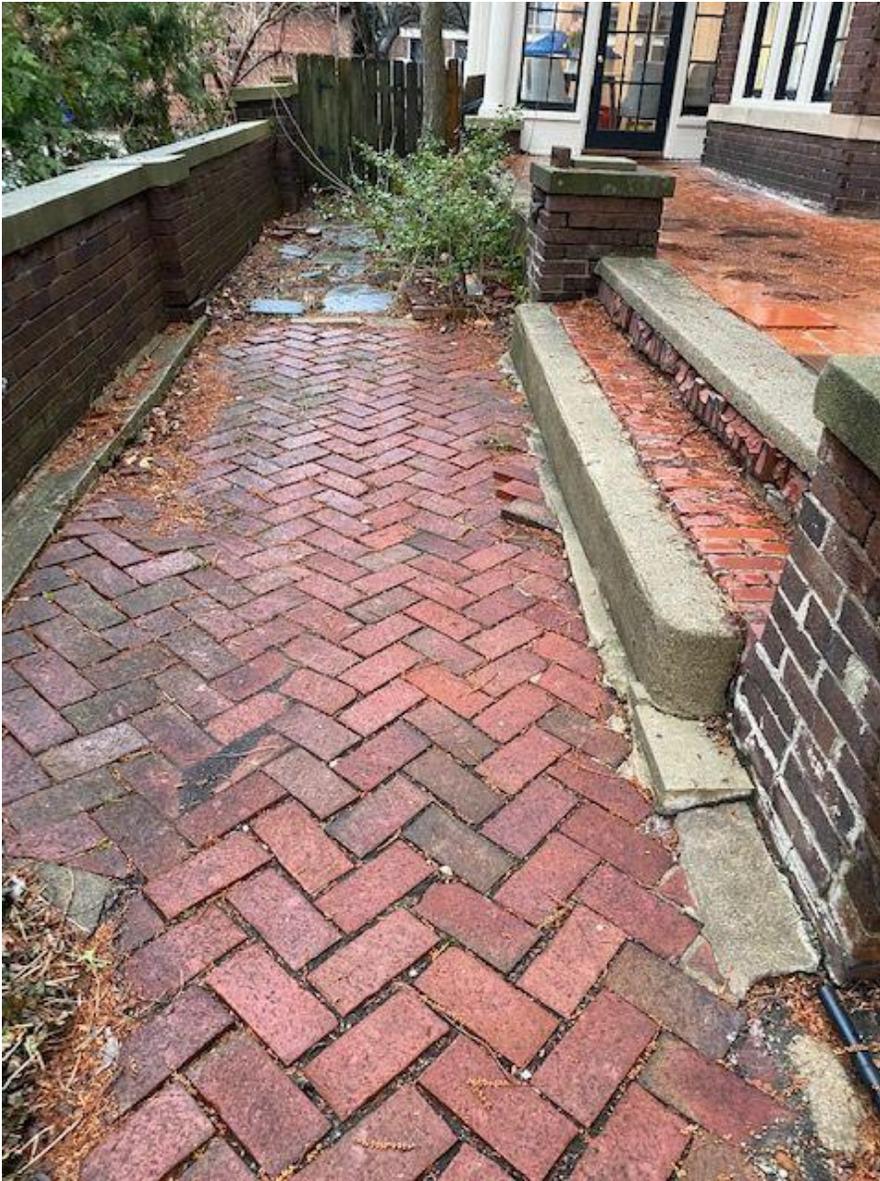
View 5: Close-up view of brick walkway near porch. The walkway will end at the same location at the end of the porch steps.
